PLUMBBOB

Project 33.5

THE INTERNAL ENVIRONMENT OF UNDERGROUND STRUCTURES SUBJECTED TO NUCLEAR BLAST.

I. THE OCCURRENCE OF DUST

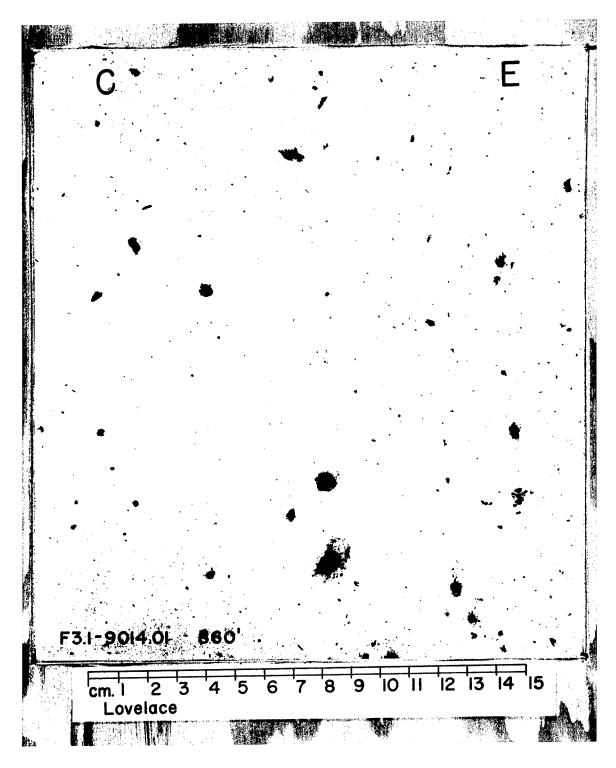
Fig. 3. 1-Type B dust collector from concrete arch shelter F3. 1-9014. 01 (Priscilla).

(a) The 3.1 Concrete-arch Structures. Figs. 3.1 to 3.4, inclusive, show the results for the arch structures located 860, 1040, and 1360 ft from GZ on the Priscilla shot. There was little difference between the control and experimental sides of the dust collectors. However, the control side in Fig. 3.4 was slightly, but definitely, denser than the experimental side. The general similarity between the control and experimental data indicate that most of the grossly visible material trapped by the dust collectors was postshot and not preshot debris. This follows because the experimental side of the tray was not uncovered until button-up, an activity which stirred up very little dirt.

such as mortar mixed with cement. This finding prompted a careful inspection of the F3.1-9014.01 shelter, and the source of the soft particulates was easily established. Just above one of the trays several defects in the original concrete had been patched with cement mortar. This spalled in considerable amount along with some of the harder concrete of the main structure. Such a finding cautions against patching the inner surfaces of shelters designed for blast protection because certainly there is enough coupling between the air shock and the soil and the soil and the structure to cause spalling of any material which does not have a firm bond with the structure wall.

- 10. Finding of many soft particles of concrete mortar in shelters where grouting or patching of defects was accomplished demonstrates the inadvisability of using such construction techniques in blast-protective structures.

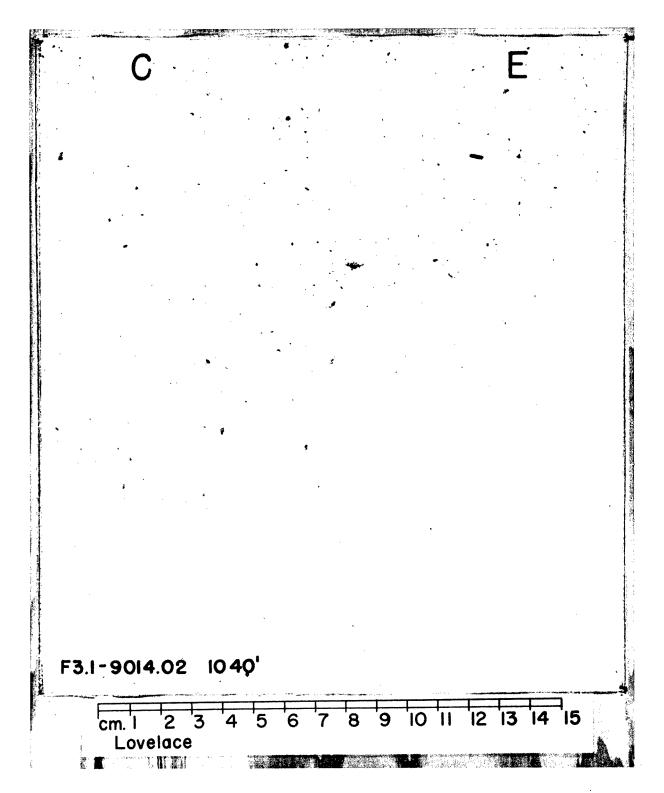
Fig. 3.2-Type B dust collector from concrete arch shelter F3.1-9014.02 (Priscilla).

This conclusion is further supported by the evident effect of range on the total amount and gross particle size of the material captured, e.g., compare Figs. 3.1, 3.2, 3.3, and 3.4 for the 860-, 1040-, and 1360-ft ranges, respectively. The largest particulates are seen in Fig. 3.1 at the closest range, some being as sizable as 5/16 in. in diameter, with a few slivers 3/8 in. long by 1/8 in. wide. It is of interest to note that some of the particles shown in Fig. 3.1 were definitely hard concrete, and others were of softer material,

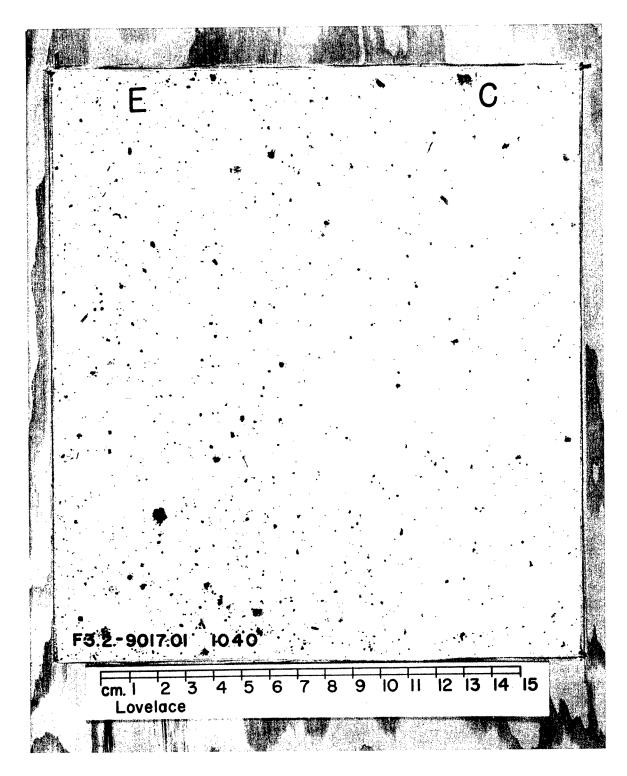
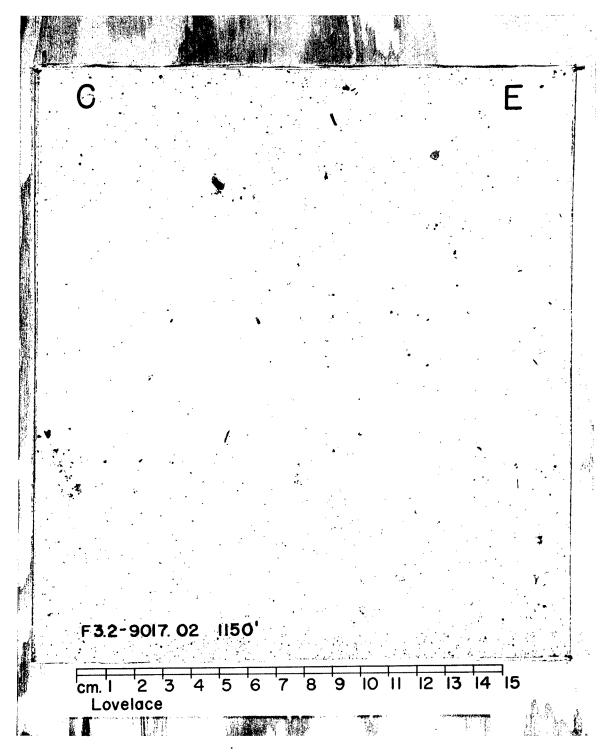
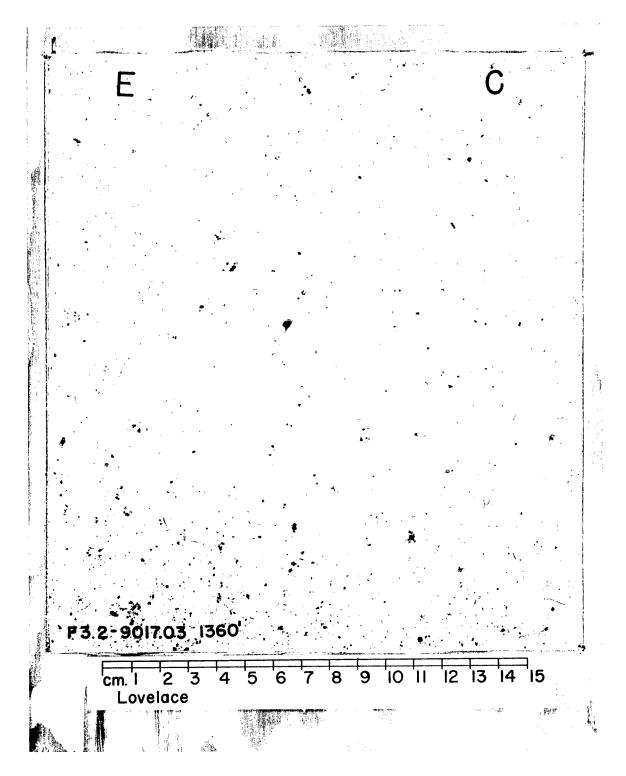
- The 3.2 Circular Concrete Structures. Results applicable to the three circular 3.2 structures are in sharp contrast with those just noted for the arch 3.1 shelters. The difference will be readily apparent from a study of Figs. 3.5, 3.6, and 3.7 showing the transparent preparations from the trays recovered from those structures at 1040, 1150, and 1360 ft, respectively. First, the apparent effect of range was less marked for the 3.2 than for the 3.1 structures, although it was true that there were more of the larger and harder concrete particles at the near compared with the far range. Second, many of the particles captured proved to be pieces of wood and much dirt. This occurred because the end bulkheads of the circular structures were of wooden construction. The wood "spalled," and dirt was forced into the shelters through the small cracks separating the timbers, thus accounting for the third difference between the arch and circular structures; namely, the heavier contamination of the trays recovered from the circular shelters.

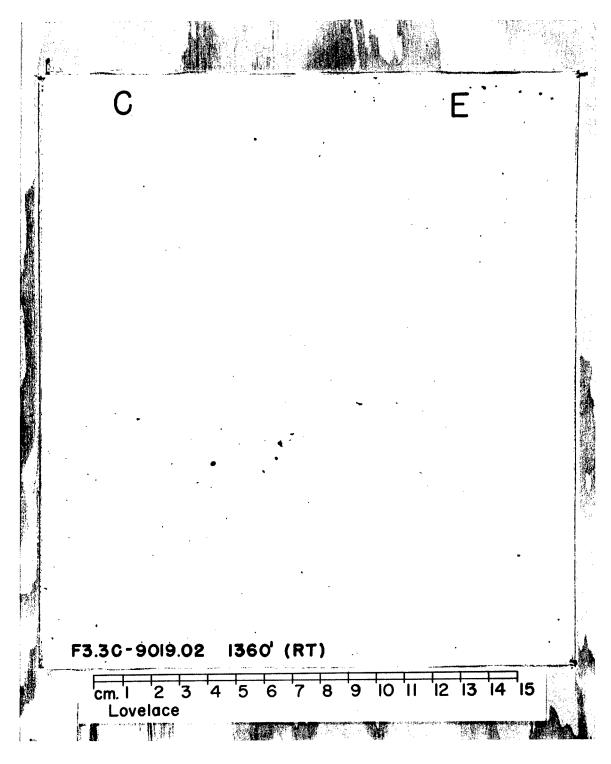
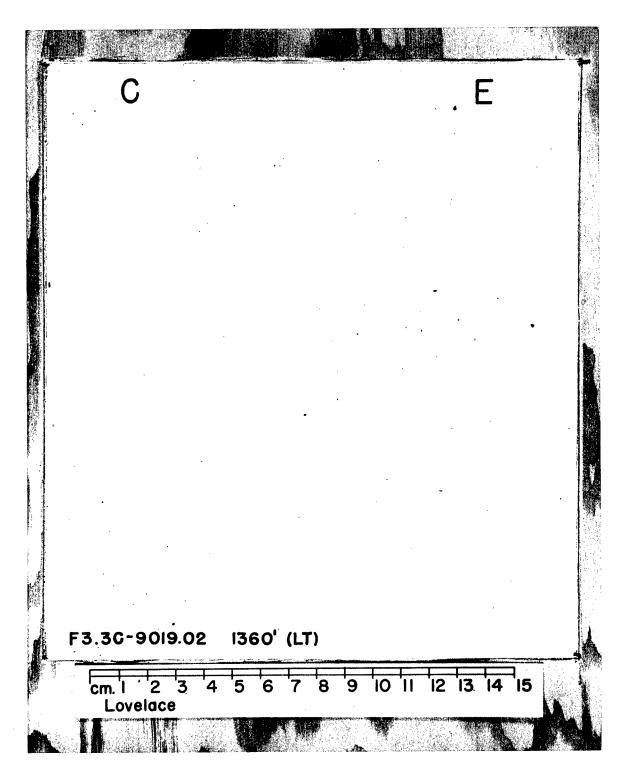
- (c) The 3.3C Steel-arch Structure. Photographs of the two paired dust collectors recovered from the steel quonset structure are shown in Figs. 3.8 and 3.9. The structure preshot was quite clean, and the relative pre- and postshot contamination of the dust collectors apparent in the figures suggests that the steel arch on concrete is a useful means of avoiding dirt in blast-protective structures. However, the concrete-arch structures at the same range (1320 ft) also proved "clean," and the data are not sufficient to indicate whether or not the concrete deck in the 3.3C shelter would have spalled if exposure had been much closer to GZ.

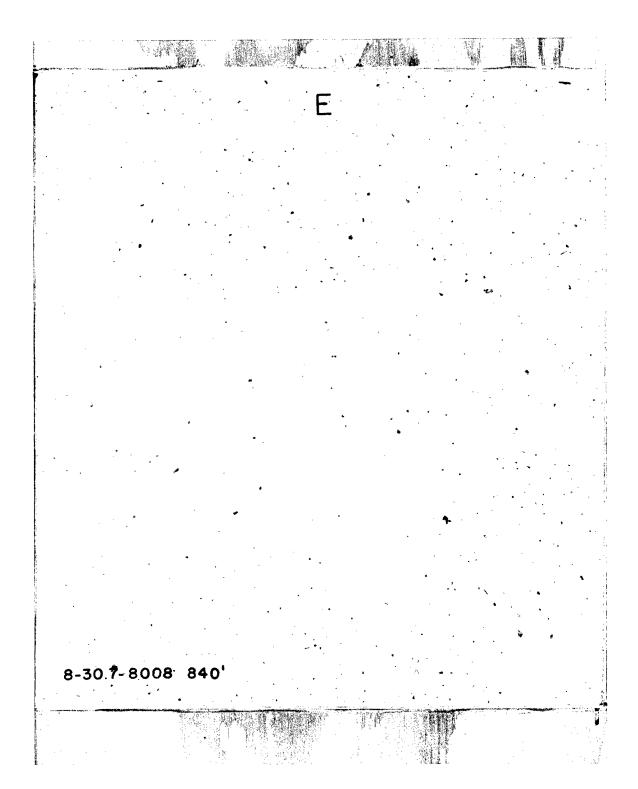
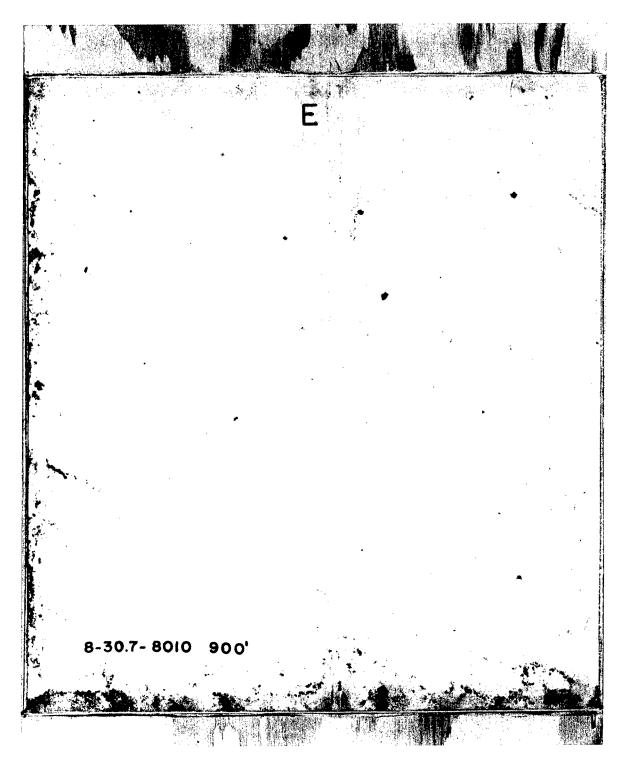
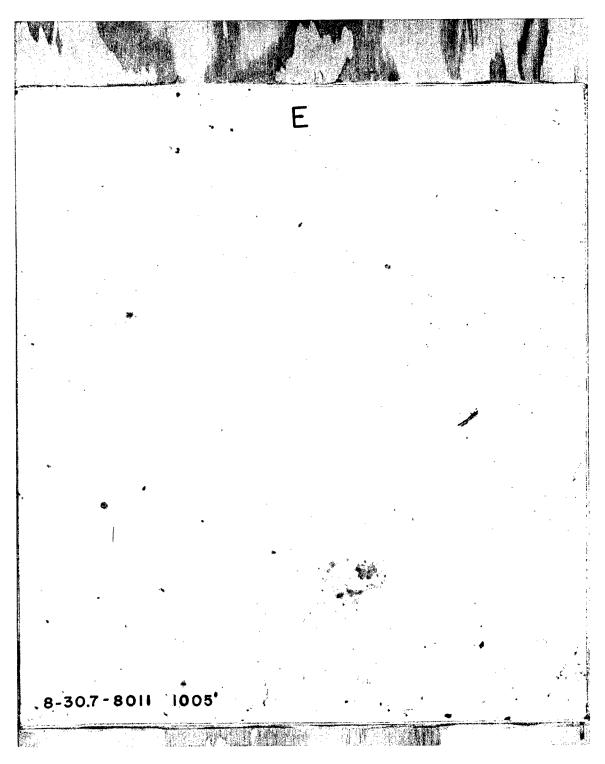
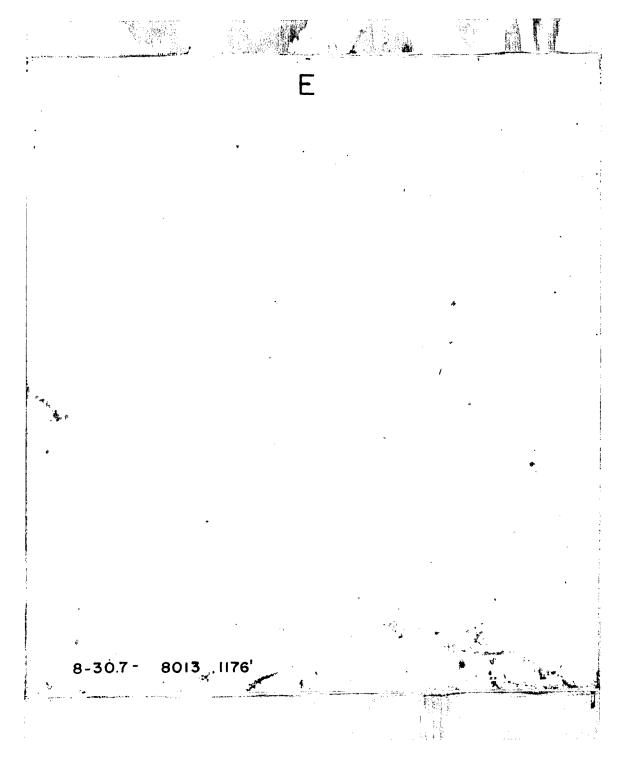
(a) RA Shelters. Four heavier rectangular structures, RAa, RAb, RAc, and RAd, located 840, 900, 1005, and 1176 ft from GZ, respectively, can be treated as a group. Figs. 3. 10 to 3. 13 show the particulate material contaminating the type B experimental, paired sticky-paper collectors removed from the structures. For comparison, Fig. 3. 14 shows a paired sticky-paper control prepared under clean conditions in the laboratory and photographed in the same way. A variation with range, as was the case with the Priscilla shelters, was noted and is apparent from the figures, particularly with regard to the size and number of the gross particles to be seen in the 840-ft structure (Fig. 3. 10) compared with those at 900, 1005, and 1176 ft. The material on the 8008 preparation was composed mostly of dirt, but a few small hard pieces of concrete were easily identified.

Not too evident from the figures, but very much so from the original preparations was the presence of a considerable amount of very fine dust on the trays from the 8010 (RAb), 8011 (RAc), and 8013 (RAd) shelters. This was particularly surprising in the case of the 8013 structure, which was vacuum cleaned on D-1 (see Table 2.2). The presence of very fine dust, which was in contrast to the "closed" Priscilla structures, was verified postshot by inspection of the shelters and samples from the floor. This finding tempts one to draw the conclusion that there was a "leak" in the forward rectangular structures. Since the main and escape hatch doors were all found closed on recovery by Program 33 personnel, who were the first to enter all the structures, and since no structural failure or open conduits were noted, about the only portion of the shelter left to "suspect" is the ventilation system.

It was postulated that the fine dirt found in the shelters was blown in through the ventilation ducts, one of which was present in each structure. If this is true, the dirt either was present in the duct preshot or was present preshot inadvertently as a contaminant in the sand filter guarding the ventilation intake assembly, or it arose from outside, being blown by the blast winds down the ventilation shaft and through the sand filter.

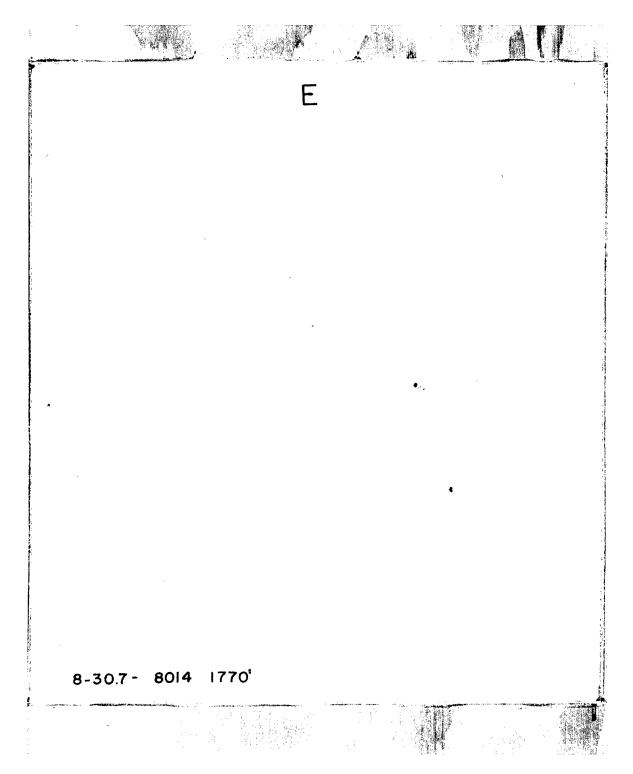
- (b) RC Structures. Figs. 3.15, 3.16, and 3.17 show the data documented from the type B experimental dust collectors for the lighter rectangular structures RCa, b, and c, respectively, located 1770, 2430 and 4320 ft from GZ. Two of these, RCb and RCc, were vacuum cleaned on D-1. It is obvious from the figures that gross contamination with dust was minimal.
